# **Ram Heavy Duty Exterior Lighting Modifications 2019+**

## EXPLANATION OF BULB OUT DETECTION FEATURE

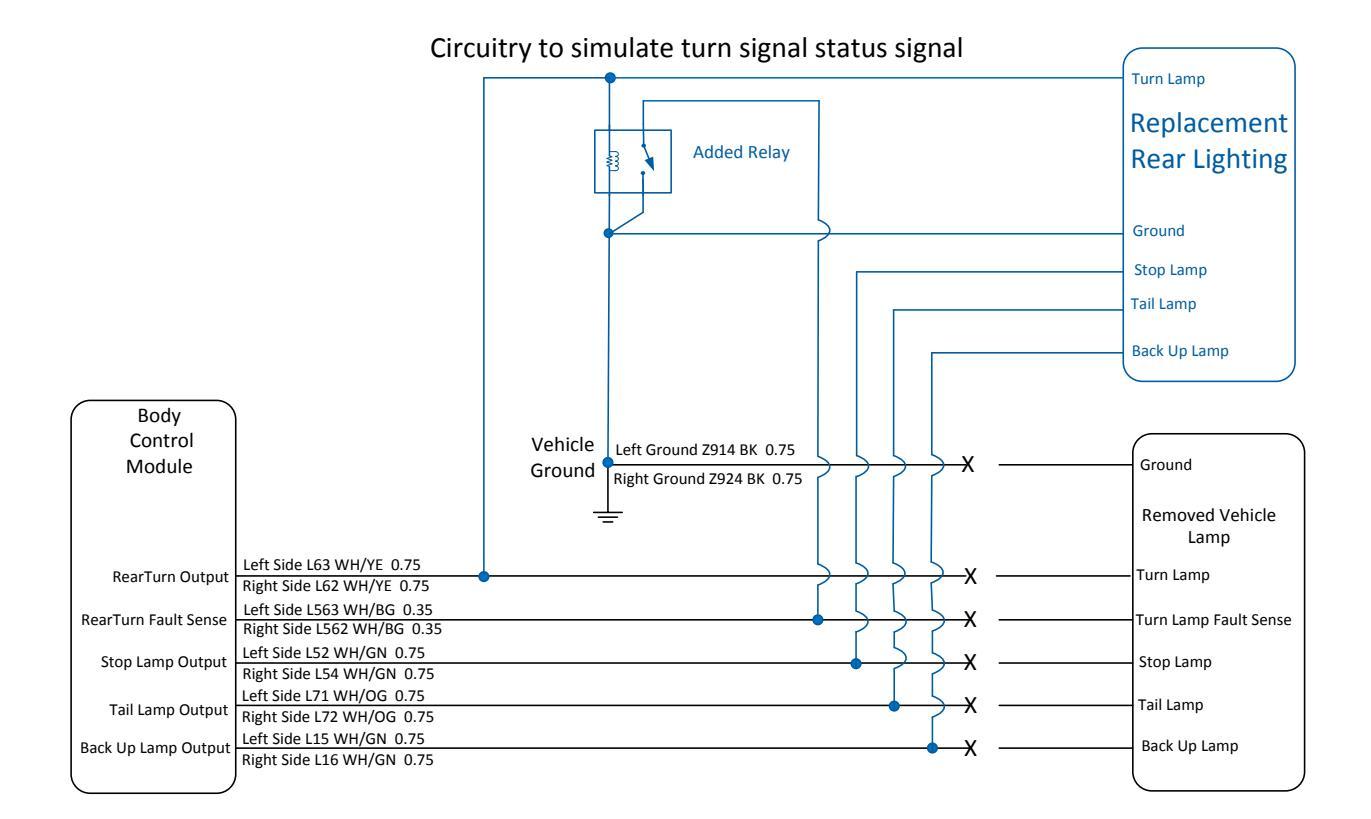
On vehicles with LED rear lighting and whithout a VSIM (refer to METHOD B) or not adding the sales code LB6 (refer to METHOD A), a relay will need to be wired into the circuitry to simulate the original equipment turn signal status signal if the original equipment lamps are removed and replaced. The circuit provides a ground signal to the Body Control module that coincides whent the respective turn signal is on. There will need to be a separate relay and signal for each side of the vehicles rear turn signals. Refer to the diagram below. Added circuitry in **BLUE**.

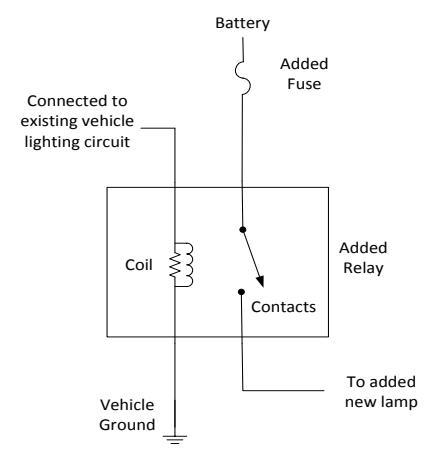
If these ratings are insufficient to support the desired lighting, a relay must be used. The diagram below shows and example of how the relay should be wired to power additional lighting.
