Ram Heavy Duty Exterior Lighting Modifications 2019+

[Title] Ram Heavy Duty Exterior Lighting Modifications 2019+

REAR BULB OUT DETECTION DISABLING

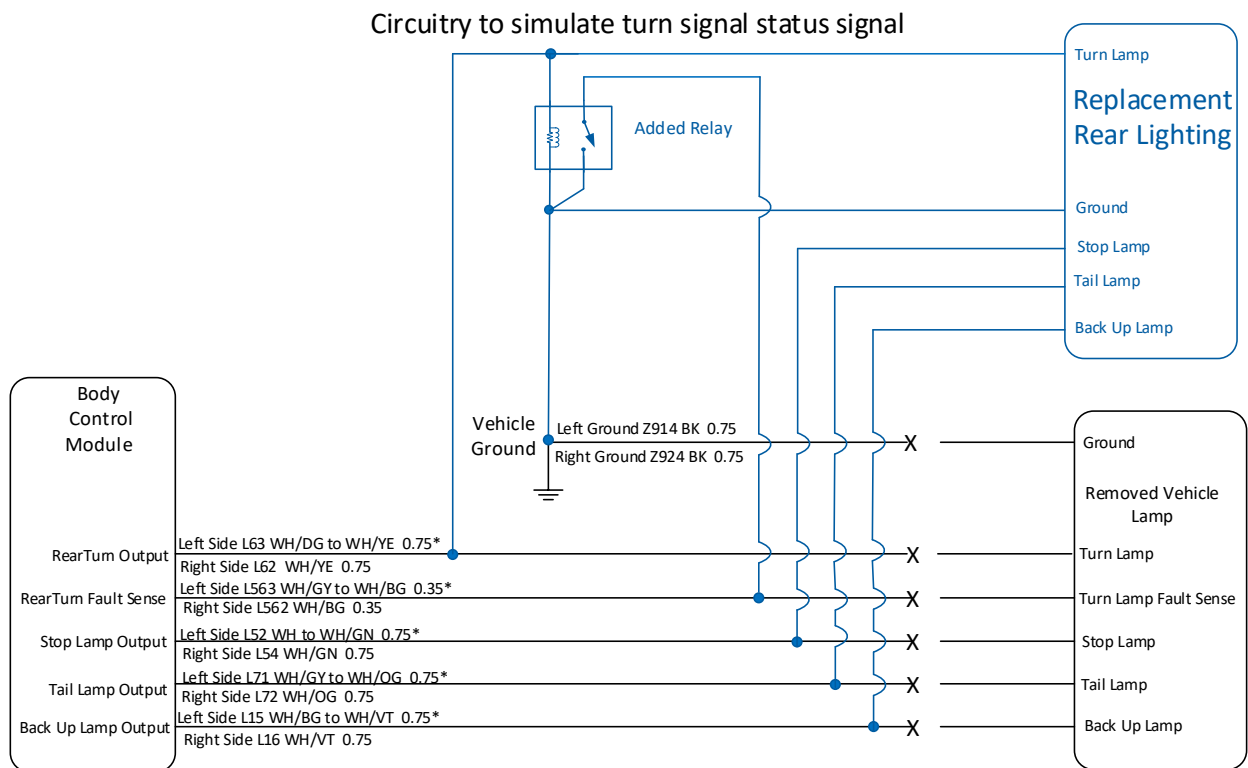
On vehicles with LED rear lighting and without a VSIM (refer to METHOD B) or not adding the sales code LB6 (refer to METHOD A), a relay will need to be wired into the circuitry to simulate the original equipment turn signal status signal if the original equipment lamps are removed and replaced. The circuit provides a ground signal to the Body Control module that coincides when the respective turn signal is on. There will need to be a separate relay and signal for each side of the vehicles rear turn signals. Refer to the diagram below. Added circuitry in **BLUE**.

* On Pick Up trucks the wire color changes at the chassis to lamp jumper in-line connector.
On Cab Chassis the color listed first runs the full distance to the lamp

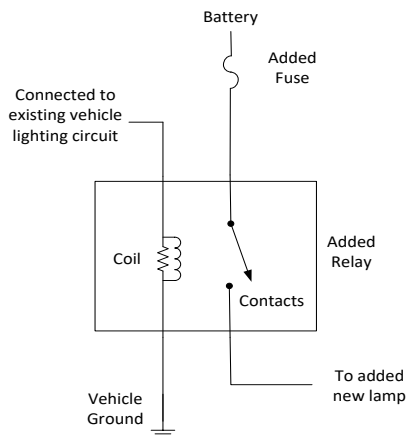
If these ratings are insufficient to support the desired lighting, a relay must be used. The diagram below shows an example of how the relay should be wired to power additional lighting.

Note that these ratings are separate for the left and right circuits, but the wires CANNOT BE PHYSICALLY COMBINED to double the max continuous current rating. Instead, left side lighting should be wired to the left side circuitry and right to the right to take full advantage of the current maximums on each sides of the vehicle.
